Juniata River Subbasin Survey

SUSQUEHANNA RIVER
BASIN COMMISSION

The Susquehanna River Basin Commission (SRBC) conducted a survey of the Juniata Subbasin from June to November 2004. This survey was part of SRBC's Subbasin Survey Program, which is funded in part through the United States Environmental Protection Agency (USEPA). This program consists of two-year assessments in each of the six major subbasins (Figure 1) on a rotating schedule.

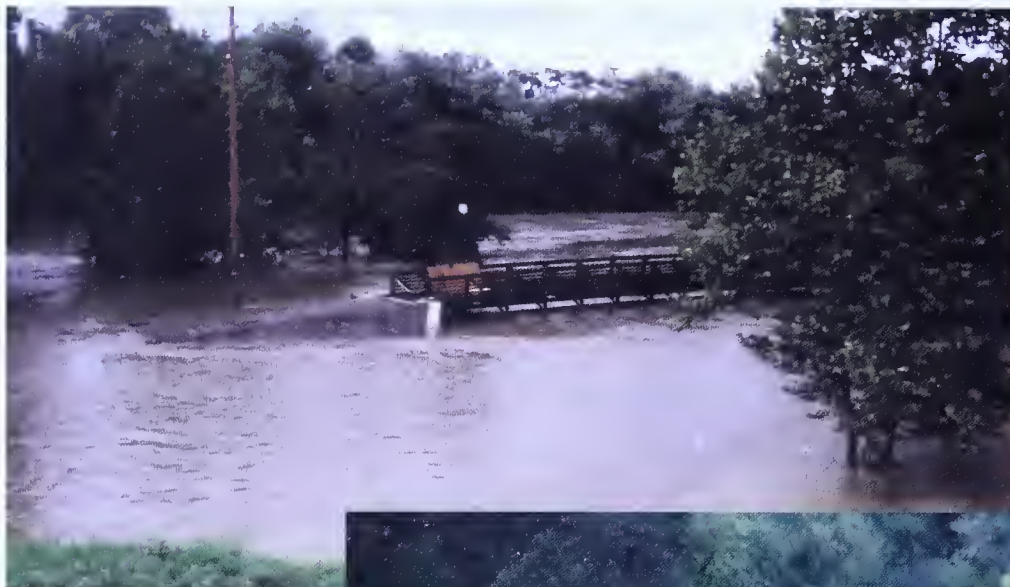
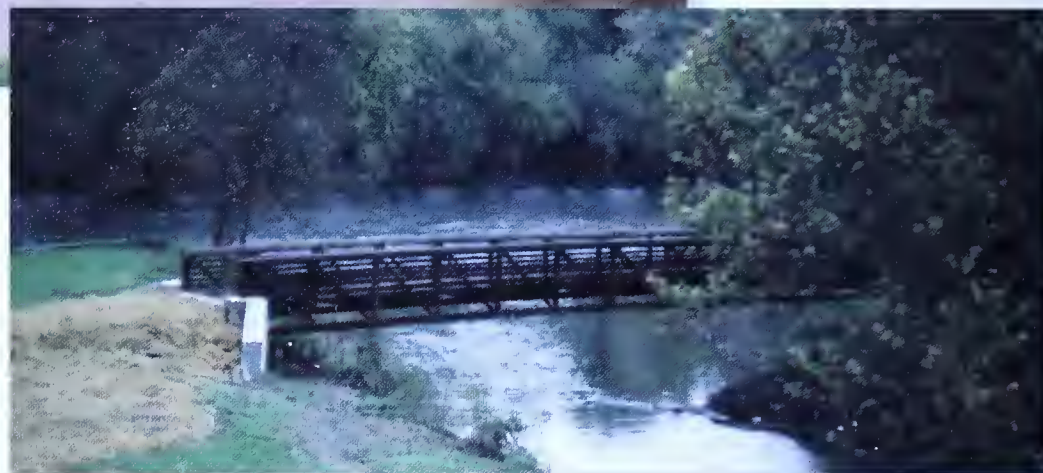
Photo at left:
September Flooding of
Juniata River and Crooked
Creek from remnants of
Hurricane Frances,
Huntingdon, Pa.

Photo below:
Confluence of Crooked Creek
and Juniata River at normal
flow, Huntingdon, Pa.
